Structure of the Gold-Silicon Eutectic

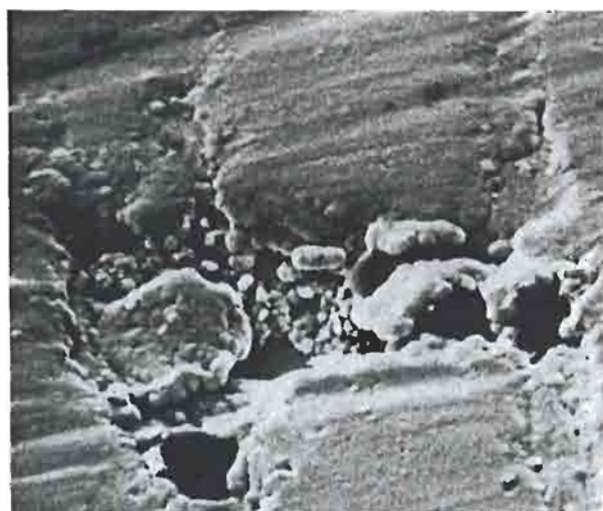
Fig. 4 Gold beginning to spread over a particle of residual polishing compound in a triangular pore in 0.2 micrometre gold plate. The gold would eventually fill the pore but probably only as a rather spongy deposit giving unreliable protection. ($\times 5750$)

this would have grown right across the pore but there would still have been a gap beneath it. Fig. 4 illustrates another way in which gold gradually covers over a pore as the thickness of the plating builds up. The pore in Fig. 4 contains one small inclusion at the lowest point of the triangle and another in its top left-hand corner but in the right-hand corner is a rather large inclusion with gold beginning to deposit over it. The feature projecting from the left-hand side of the triangle may be a fourth inclusion almost completely covered by gold, or it may be a flap of gold growing out across the pore, similar to that shown in Fig. 3. Whichever mechanism results in eventual covering of the pore by gold, there will still be a local defect and possibly even a group of minute discontinuities in the plating where the pore was originally located.

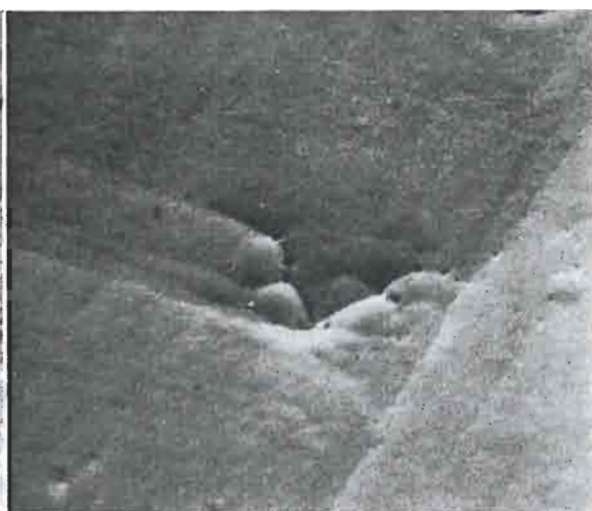
Fig. 5 A gold deposit 2.0 micrometres thick which has covered over a pore that was present when the plating was thinner but still shows obvious weakness where the pore was situated. ($\times 4500$)

Fig. 5 shows a much thicker (2 micrometre) deposit; the feature at the centre of the photograph is probably one of the triangular pores of the type shown in Figs 2, 3 and 4 now largely covered by gold but still clearly a weak point in the plating.
